# Manhole Inspection Summary

Manhole # S39S\_\_026MH

Insp Date: **2/17/09 1:34 PM**

**Location** Address: **1401 key hw**

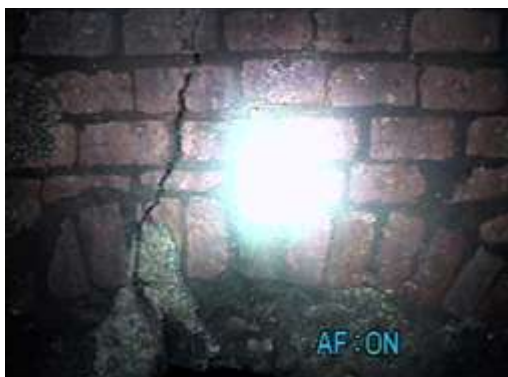
Defect 4

Condition: ☐ Sound ☒ **Cracked** ☐ Root Intrusion ☐ Loose Brick ☐ Deteriorated

cracked barrel

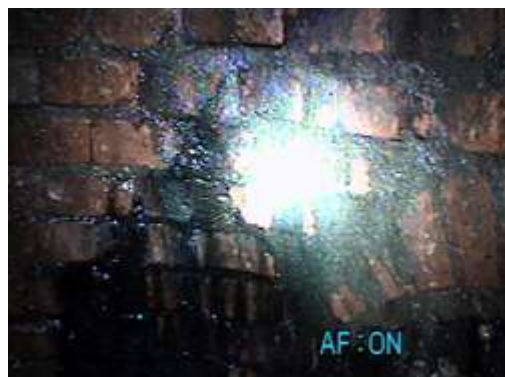
Defect 3

Infiltration: ☐ None ☐ Joint ☐ Cracks ☐ Mortar ☐ Roots ☒ **Wall**

infiltration

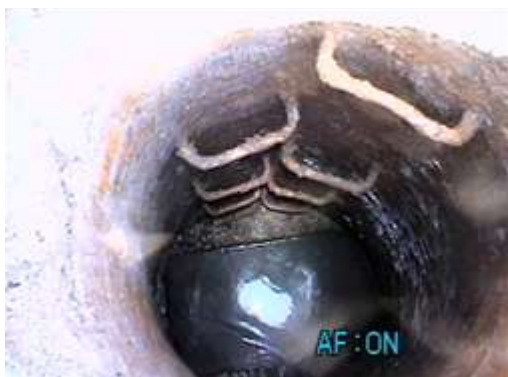
Defect 2

Count: **8** Missing: **0** ☒ **Corroded**

corr steps

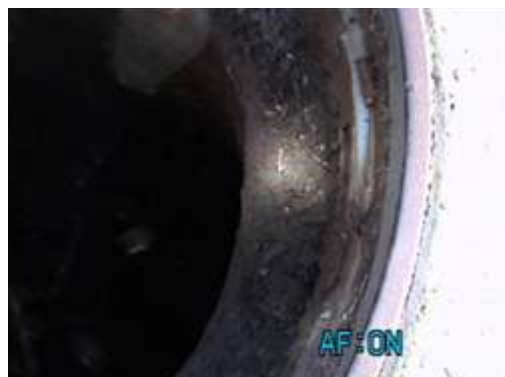
Defect 1

Offset: **3** (in.)

offset

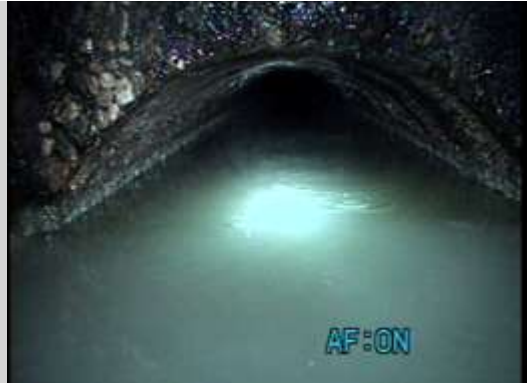
12 O'Clock Outflow

30 in. Circular Gravity Sewer  
Pipe Out @ 12 O'Clock

Invert Depth: **13.10** (ft.) Flow Characteristics: **Slow**

Infiltration: **None** Pipe Seal Cond: **Unknown**

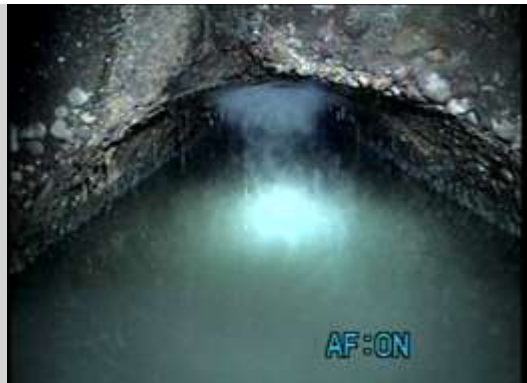
6 O'Clock Inflow

30 in. Circular Gravity Sewer  
Pipe In @ 6 O'Clock

Invert Depth: **13.00** (ft.) Flow Characteristics: **Slow**

Infiltration: **None** Pipe Seal Cond: **Unknown**

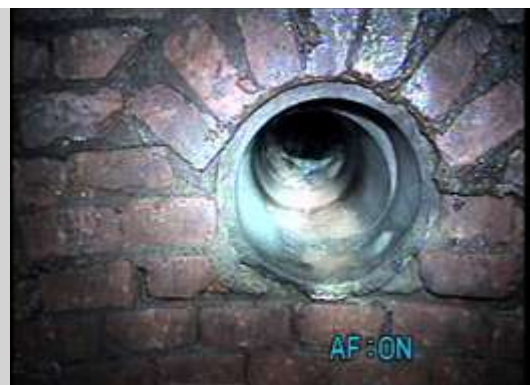
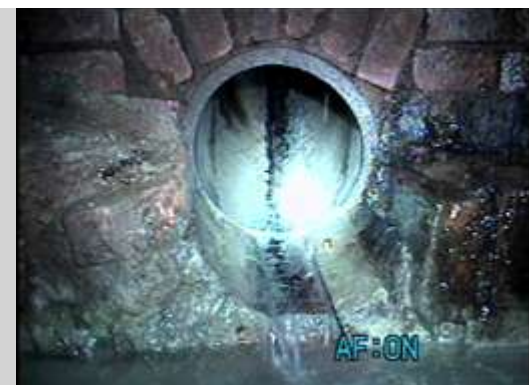
9 O'Clock Inflow

8 in. Circular Gravity Sewer

Pipe In @ 9 O'Clock

Drop In @ 9 O'Clock

Drop: **Outside** **Direct**

Drop Condition: **Open**
